Boundary wall stability

The Leazes, Stroud

Stroud Town Council

Report Issue: 1
Author: John Topp
Status:
Date: December 2017
Revisions: -

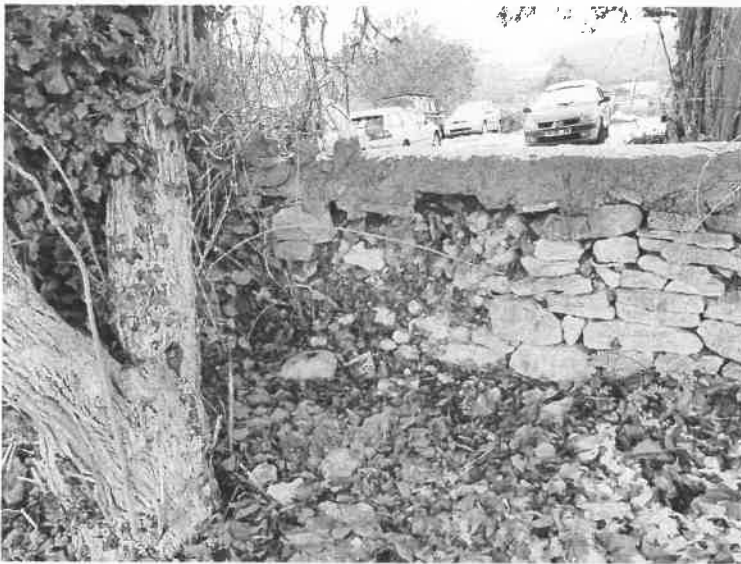
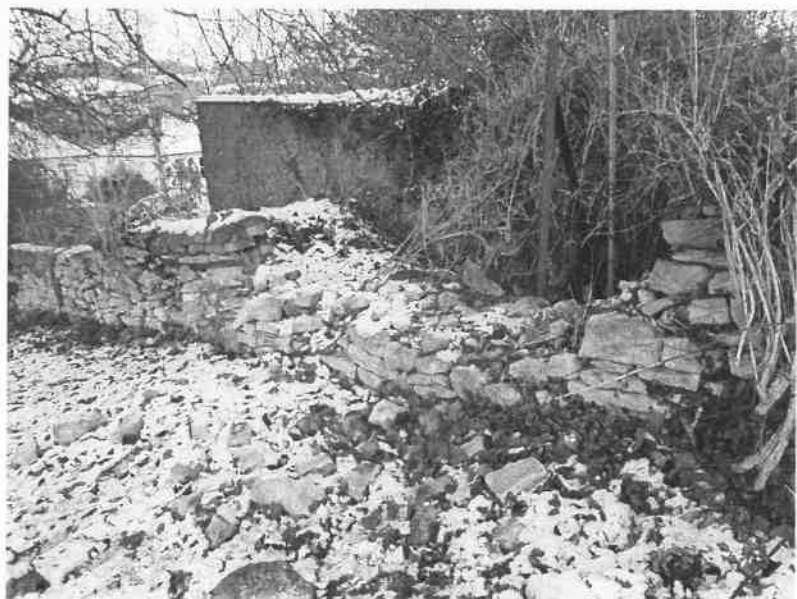
2.1 Section 'a'

This wall is of dry-stone construction with an in-situ cementitious capping, approx. 500mm thick x 900mm high.

There is significant 'voiding' where the face stone has collapsed, and is 'bridged' by the capping. There is also a section fully collapsed near the corner of the allotments. Reconstruction is required.

Extensive rebuilding will be required for the dry-stone wall to sections 'a' and 'b', being the eastern boundary with the car park and allotments, but this should be further exposed to determine the full extent. Even if full replacement is required, this is at least a straightforward element of work to quantify. Similarly, the modest repairs to the northern boundary with Far Leazes are easily quantifiable. Wall section 'c', retaining gardens to the south, is however far more significant and represents a serious cost risk. A long term repair for wall section 'c' would entail either reconstruction, or the addition of a further retaining element inside the boundary of the recreation ground. I will describe these options briefly as follows:

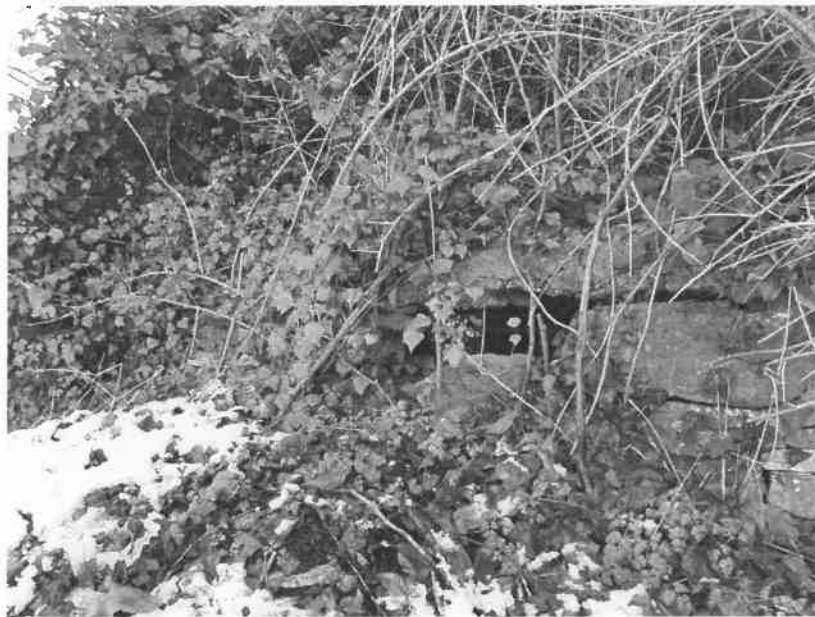
2.2 Section 'b'

This is a continuation of the dry-stone wall to section 'a', except this also acts as a retaining wall for a relatively modest change in ground levels (allotments lower). The difference in level was not accurately measured, and access to this section of wall, both visual and physical, was hampered by vegetation. Despite this, there are clear areas of collapse and distress, and it is likely that removal of attached vegetation will further disturb decayed masonry. Where visible, this wall has a 'cock and hen' coping. The SE end of the wall is inaccessible due to presence of brambles, but further voiding is visible.

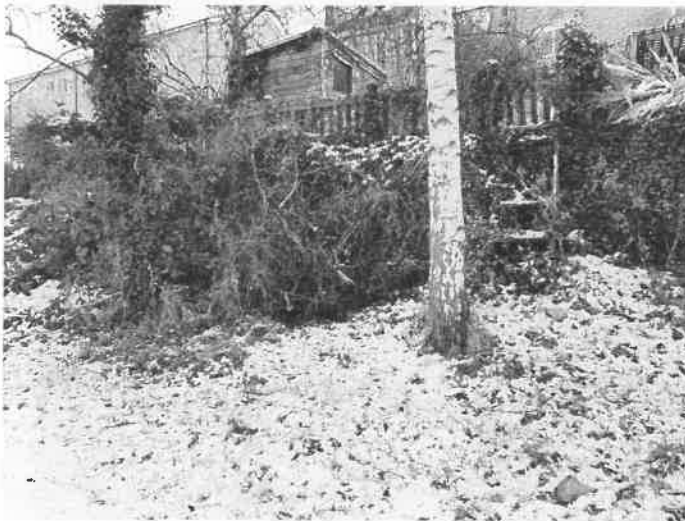
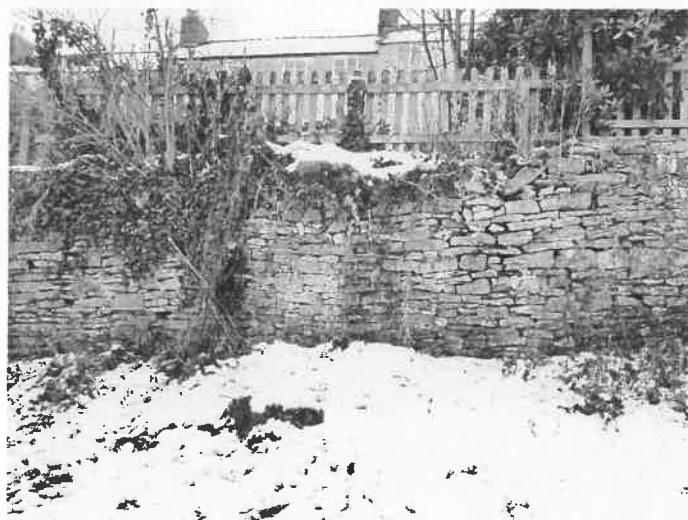
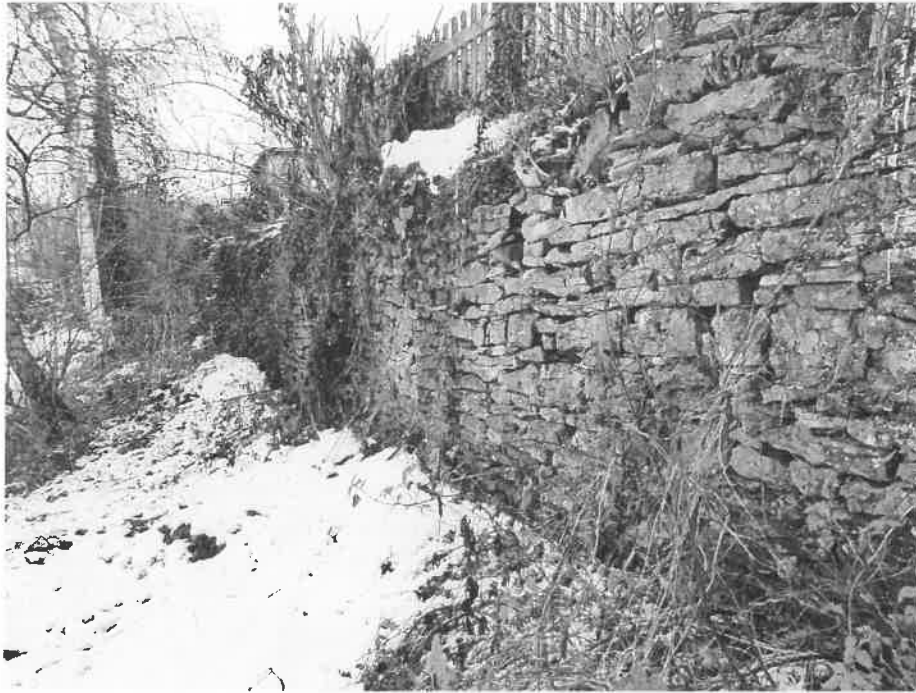
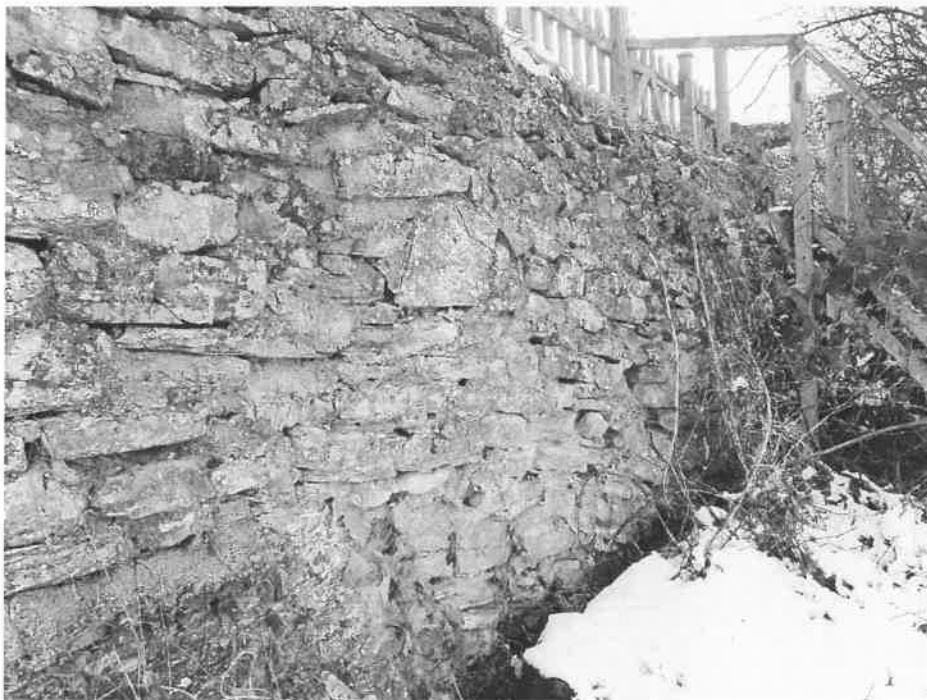
2.3 Section 'c'

This wall is a significant retaining structure. It runs along the rear of the properties to Summer Street, and retains gardens to a height of approximately 1.5m. The current ground level on the recreation ground side of the wall may however be misleading, as the profile suggests that this may have been raised gradually over a considerable period of time, by deposition of waste vegetation. There may therefore be a 'mantle' of superficial matter with high organic content, which means the 'effective' height of the retaining structure could be closer to 2.0m.

Again, the SE end of the wall is concealed by brambles, and there is further vegetation across the face of the wall, but this is again of dry-stone appearance, and is significantly distorted. Some mortar 'pointing' has been added in the past as an attempted repair.

Wall distortions are apparent in both vertical and horizontal planes, indicating relative differential vertical movements, and lateral displacement/rotation. The capping to the wall is largely missing, and this appears to have been the case for a considerable period of time, exposing the body of the wall to substantial weathering.

At least two of the properties on Summer Street (thought to be Nos 3 and 12) have extant access arrangements onto the recreation ground in the form of timber steps.

There are some mature trees on the recreation ground, relatively close to the wall.

There are repairs and reconstruction of the northern and eastern boundary walls which are quantifiable, but the defects present in the southern retaining wall (section 'c') are of considerable importance. The remedial options are costly, and present numerous legal and procedural difficulties. It is extremely difficult to determine the liabilities associated with this problem, and I urge caution in acceptance of such.

Reconstruction of the retaining wall on its current alignment would inevitably involve excavation and temporary support works within each of the rear gardens currently supported by the wall (approximately 6 No premises). At least one garden shed is close to the wall, and there may be other garden features present which would also be disturbed. A modern replacement retaining wall to match the existing would be extremely costly, as for an effective retained height of 2.0m, the reinforced concrete foundation base would need to be approximately 1.25m wide. Because of the sloping ground, the base would be best situated 'behind' the wall, therefore I would anticipate excavation into the gardens extending approximately 2.5m at garden level. In addition to the construction cost, it would also be necessary to agree the proposals with each of the owners and make-good all damage and disturbance, including that created by temporary access during construction. It will of course be necessary to first establish ownership and liability for the wall, if this is not already clear. The legality and status of the extant access arrangements also needs to be resolved.

As an alternative to the disturbance and complications of reconstruction, consideration could be given to forming an additional retaining structure in front of the existing wall, and effectively 'holding' the old wall in place. The least-cost means of achieving this would be to install a wall formed with 'gabion' baskets. These are the stone-filled wire cages, as depicted below.

Despite being a lower cost option, this would remain a significant cost, particularly bearing in mind the construction access constraints. A problem with this approach is that a gabion wall relies entirely upon the mass of the contained stone to resist the lateral force of the retained soil, and is therefore necessarily of large scale. A gabion wall in front of the existing wall, would extend approximately 1.5m further into the recreation ground, and would require the removal of the adjacent trees.

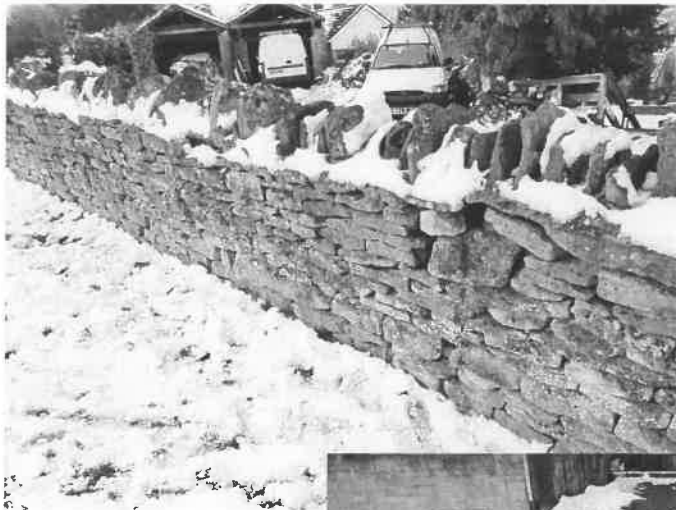
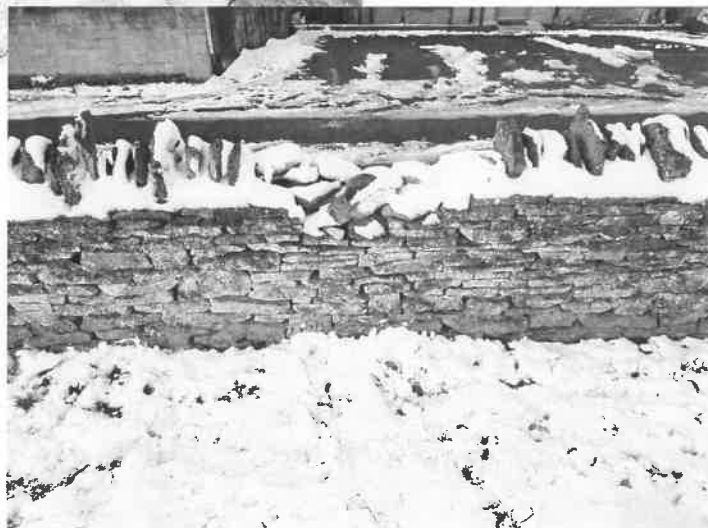
2.5 Section 'e'

This long section of wall fronting Far Leazes, is similar to that of section 'd', and is generally in good order, with no significant deviations in alignment. The wall is perpendicular and stable.

As is typical of this form of wall, individual masonry units are vulnerable to frost damage/decay, and occasional maintenance is required to replace damaged/missing stones. In this case, there are a number of such localised problems. Most notably, there are a number of areas of disturbance, which are possibly historic repairs, in the section of wall opposite Rock Cottages, and local loss of coping further east.
